Project Memo

## Quinte Conservation Authority

### Bellrock Dam Concrete Condition Assessment

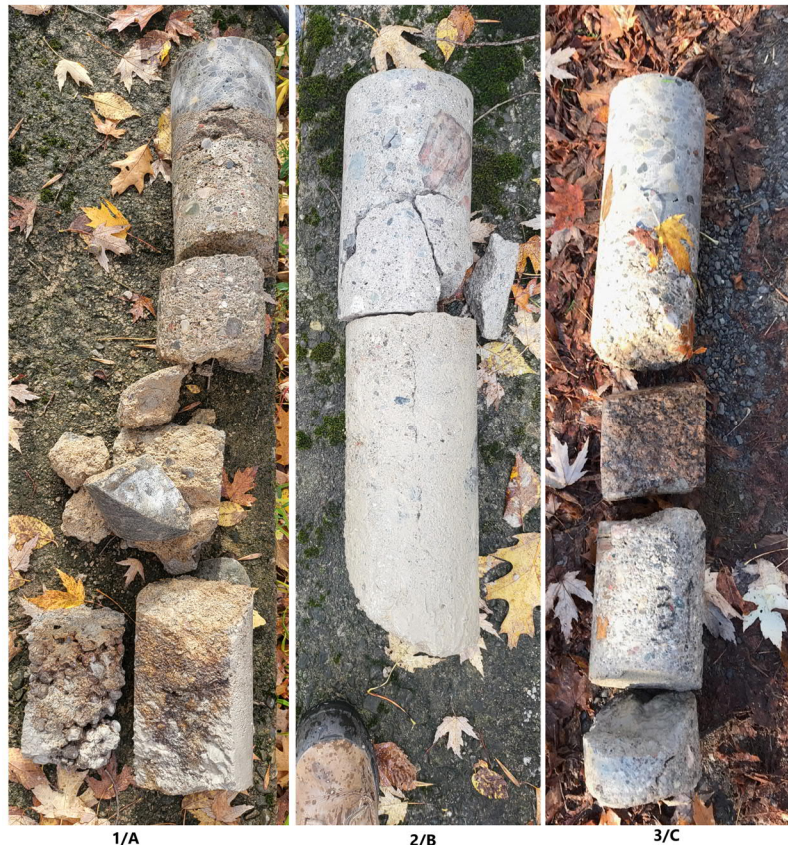
Figure 2-1: Three Concrete Cores Taken from Bellrock Dam

All three of the samples indicate concrete resurfacing had been performed on the structure in the past. The intention of the drilling program was to retrieve a sample of the concrete below the rehabilitated surface concrete. However, with varying concrete depths, drill bit/extension limitations, and concrete cracking, this was not achieved for all of the cores.

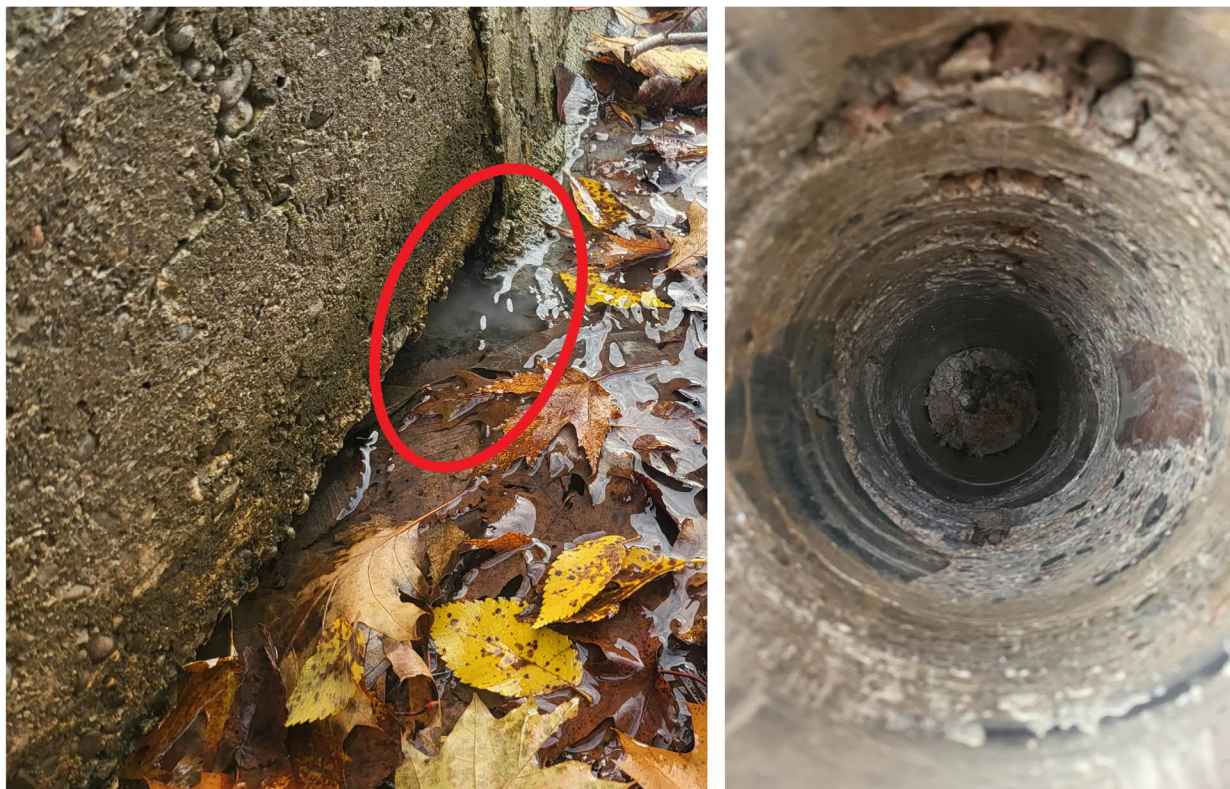
During the drilling of concrete Core 1, diluted concrete slurry was seeping through a joint in the right wingwall to the leveling slab. Figure 3-1 shows the slurry deposit downstream of Hole 1 as well a view of the inside of Hole 1.

**Figure 3-1: Slurry Deposit Downstream of Core Hole 1, Internal View of Core Hole 1**

The slurry deposit and empty core hole are clear indications that there are seepage paths from the core to the downstream face of the dam. This will impact on the anchoring program as the drilled holes must pass a watertightness test prior to the installation of anchors. It should be assumed that all of the anchor holes will need to be grouted and re-drilled to satisfy the pressure testing requirements. Procedures and requirements for this are specified on the anchoring drawings.

2. As exhibited during drilling of Core 1, it is anticipated that many of the anchor locations will have seepage paths or voids within the concrete, which will necessitate hole sealing (as specified) during anchor installation.

2. It should be assumed that all of the anchor holes will need to be grouted and re-drilled to satisfy the pressure testing requirements. This assumption should be noted in the tender documents and reflected in the pricing schedule.

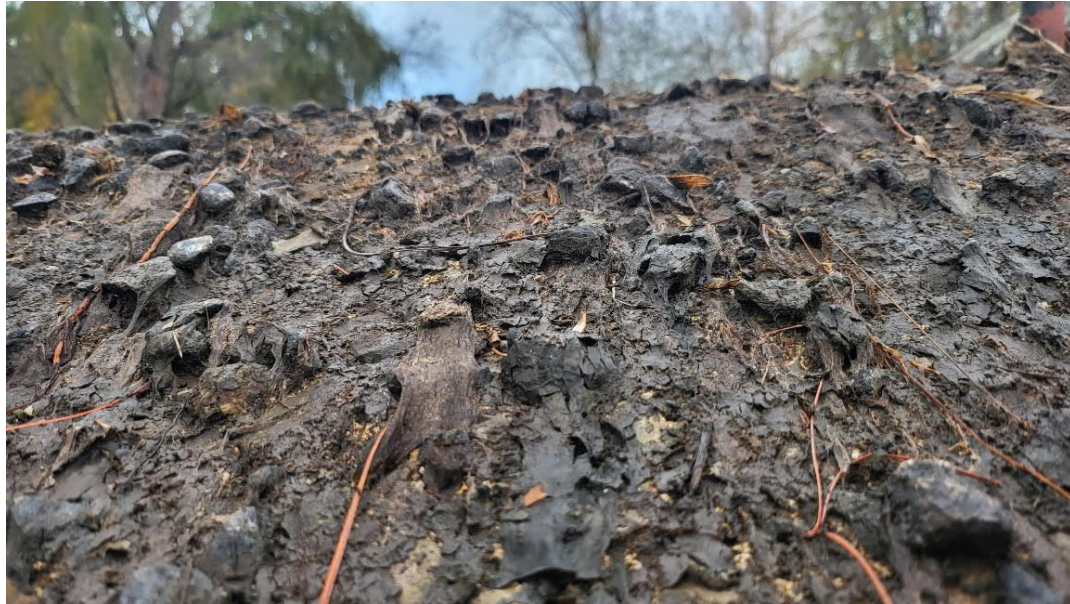
The overflow weir exhibits moderate surface erosion as shown in Figure 3-2.

**Figure 3-2: Exposed Aggregate on the Overflow Weir**

The overflow section has eroded and exposed aggregate along the entire surface of the structure. A core was taken from the crest of the overflow to help estimate the condition and strength of the concrete and to reveal the depth of the rehabilitated concrete. The depth from the sample indicates approximately 14 cm of sound concrete remaining on the surface of the overflow section.

1. The overflow weir has experienced moderate surface erosion with exposed aggregates. At this time, this surface deterioration is not a dam safety concern.

1. The condition of the overflow weir should be monitored over time during annual inspections. The current surface erosion of the weir does not pose a dam safety concern, however, should be monitored for possible accelerated deterioration.

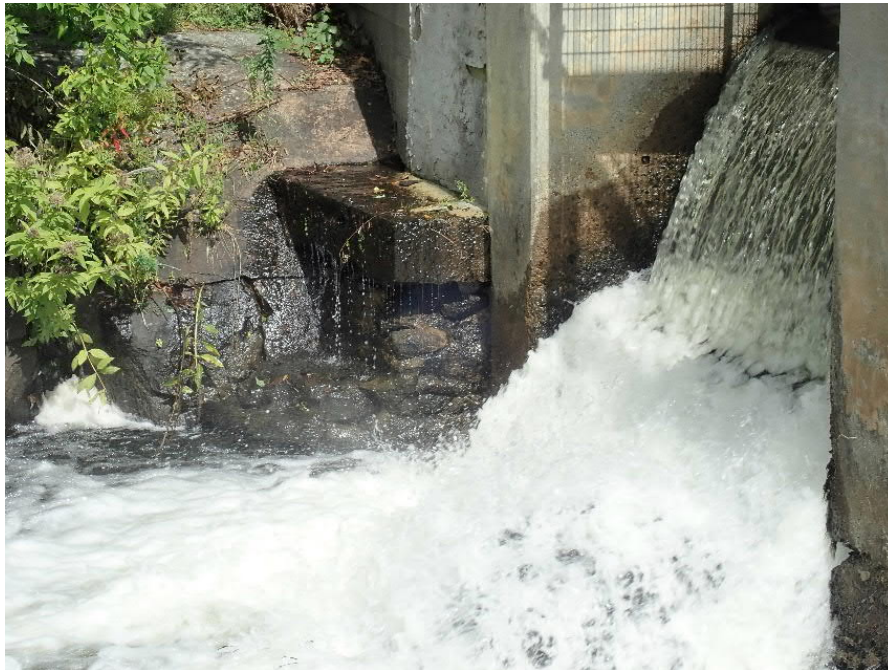
Undermining of the leveling slab downstream of the right wingwall has occurred, shown in Figure 3-3.

**Figure 3-3: Undermining of the Right Wingwall Leveling Slab**

The base of the leveling slab has eroded and undermining has begun. The undermining does not appear to have occurred beneath the dam proper. Large rocks appear to have been used in the concrete of the leveling slab, likely a different mix than has been included in the dam

3. Undermining of the leveling slab downstream of the right wingwall has occurred.
4. There is evidence of seepage along the interface of the bedrock and concrete along the downstream side of the overflow section and between the leveling slab concrete and the right wingwall. Grout injection at these interfaces may have impacts on the assumed shear strength parameters of the assumed failure plane. Crack injection may have a negative impact on the hydrostatic uplift profile if the crack injection does not target the preferred upstream portion of the dam body and it is possible the leakage will only migrate to a different location along the downstream side of the dam.

3. The condition of the concrete leveling slab downstream of the right wingwall should be monitored for further undermining. A repair plan can be considered at this time and should be implemented when undermining of the dam proper begins.

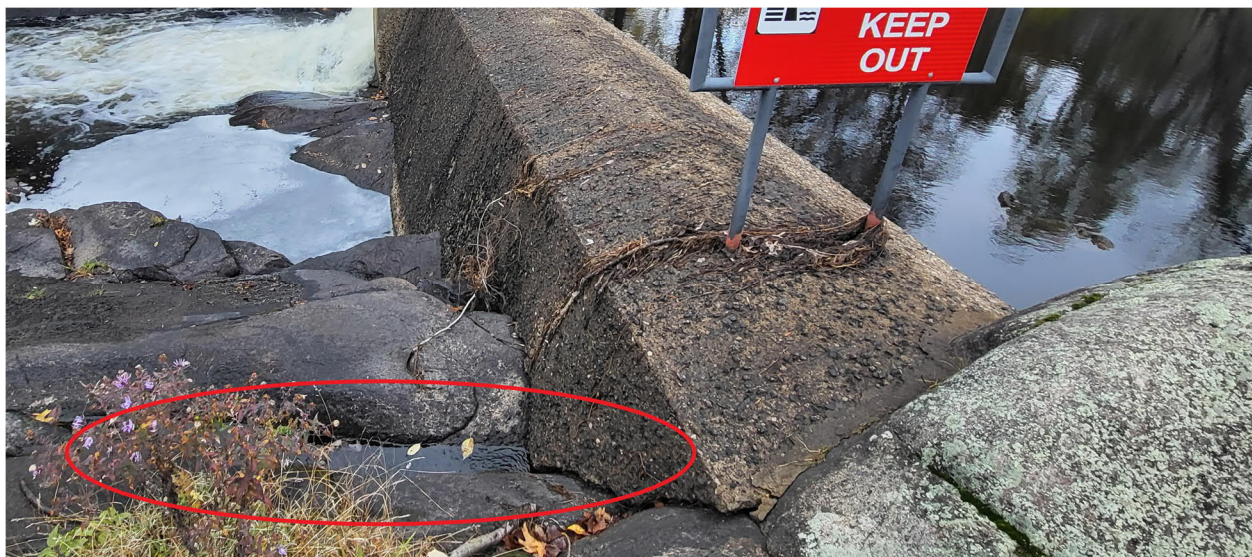
Two notable locations along the downstream toe of the dam have active leakage. The two locations are shown in Figure 3-1 and Figure 3-4.

**Figure 3-4: Seepage Points Downstream of Overflow Weir**

Seepage beneath concrete structures does not always indicate a concern for dam safety. However, seepage should be generally controlled to avoid excessive erosion to the concrete and foundation of the dam.

4. An investigation into a grouting program should be performed. The open concrete to bedrock and concrete to leveling slab crack injection should target the upstream surface of the dam.

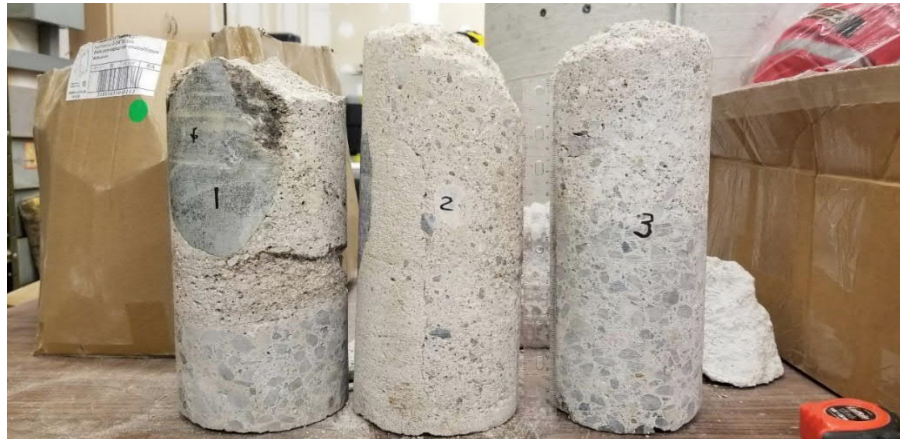
**Figure 3-5: Cores Prior to Delivery to WSP**

Core 1 contains a notably large aggregate and an area of honeycombed concrete or deteriorated concrete that was not removed and replaced during the deck resurfacing. Core 2 has longitudinal cold joint that runs nearly the entire length of the core. The majority of Core 3 appears to be the remediated concrete surface. The trimmed cores are shown in Figure 3-6 after they have been tested.

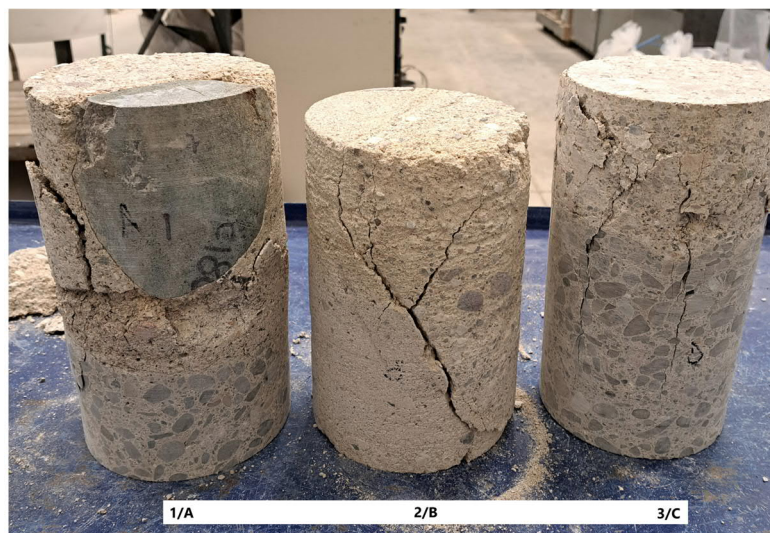
**Figure 3-6: Cores after Compressive Testing**

The results of the compressive strength testing show significant variability in the compressive strength of the concrete cores. This is to be expected in cores taken from a structure dating back to the 1950s that has undergone concrete remediations. Cores 1 and 2 contain defects that when exposed to unconfined compression tests would be expected to present lower strength results than the concrete in-situ, which inherently enjoys some degree of confinement.

5. The results of the compression test indicate that two of the concrete samples tested exhibited lower than assumed compressive strength.

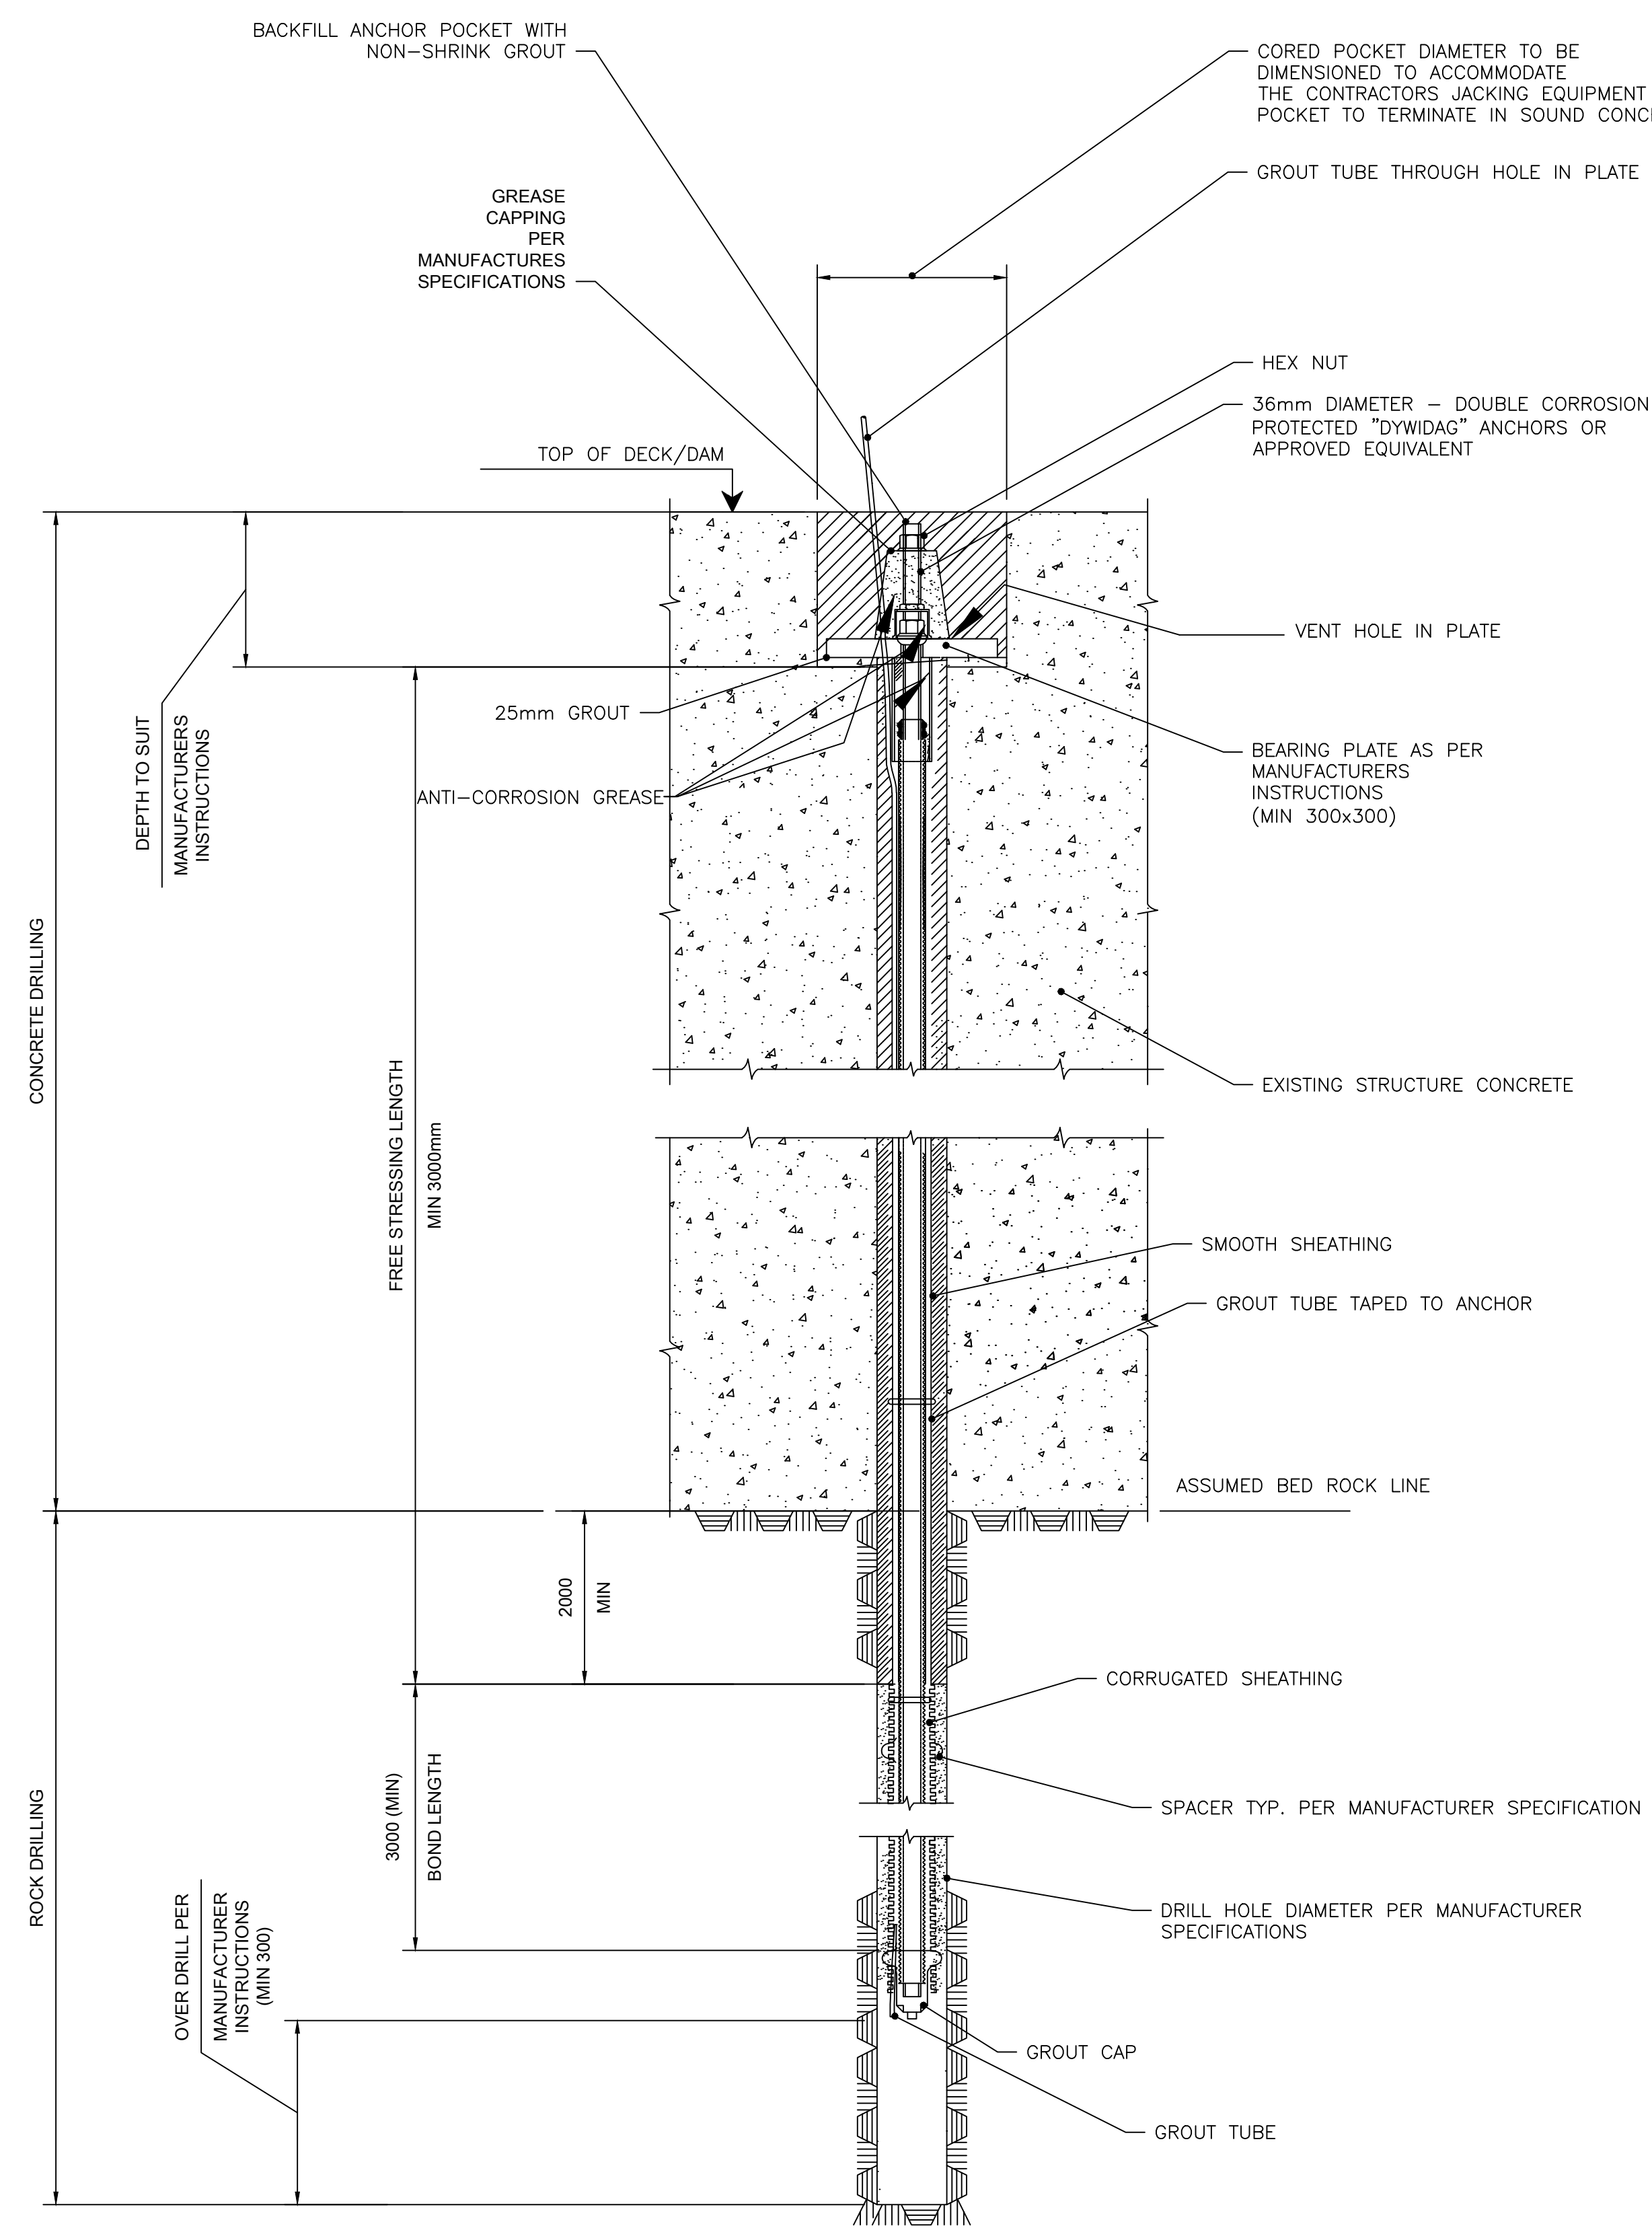
**DETAIL 1**

The strength of the concrete will have an impact on the mechanism transferring the load of the anchors to concrete of the dam. Typically, a lower strength concrete will require a larger bearing area for the anchor head (upper end) to accommodate the same compressive load. Engagement of foundation bedrock is not expected to present any capacity problems. To increase the bearing area at the anchor head, a larger steel plate can be specified, or a concrete pedestal can be formed to distribute the load to a larger area.

5. The anchor head design will be modified to accommodate for the lower than assumed strength of the concrete. Revisions to the Bellrock Dam Post Tensioned Anchors Drawing H368596-0000-220-270-0001 are shown in Appendix B.
