QUINTE CONSERVATION

Salmon River Upper Lakes Flood Hazard Mapping

Floodplain Mapping Report

Final/Rev 2

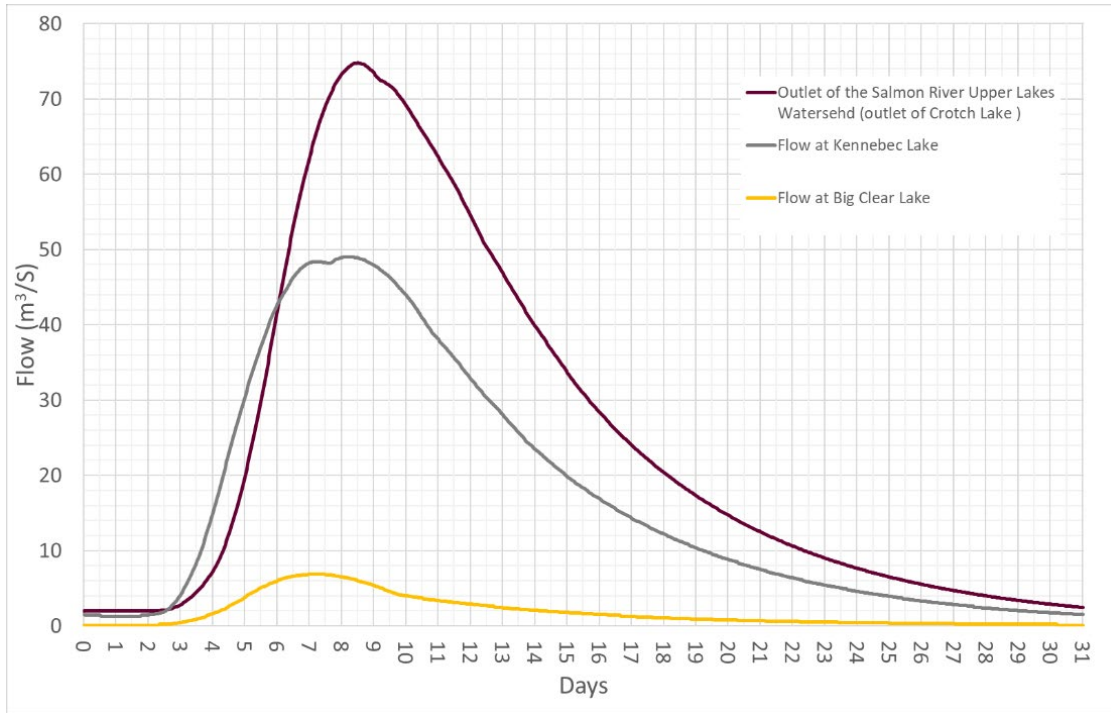
FIGURE 2-2: HYDROLOGIC INFLOWS 100-YEAR (1% AEP) FLOOD

The input flows for the hydraulic analysis were the results obtained with the hydrologic model described in KGS (2024a). The corresponding 100-year spring flood hydrographs at different locations within the study area are provided in Figure 2-2.

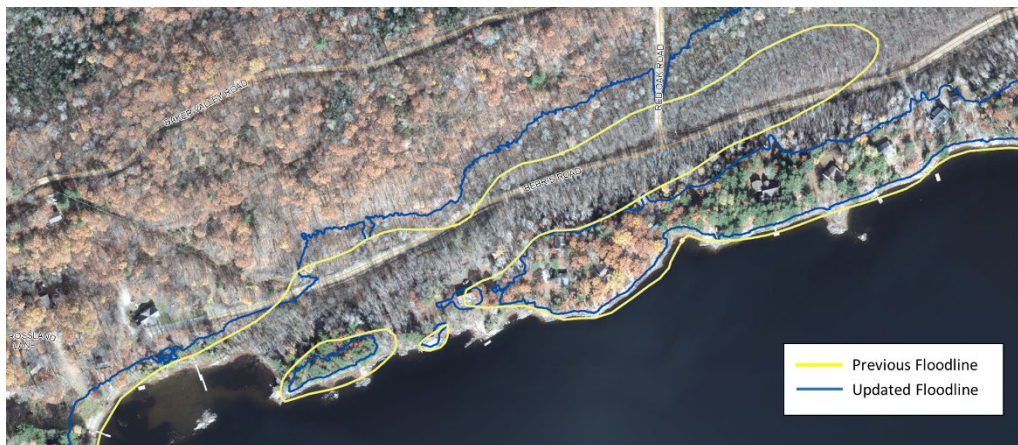
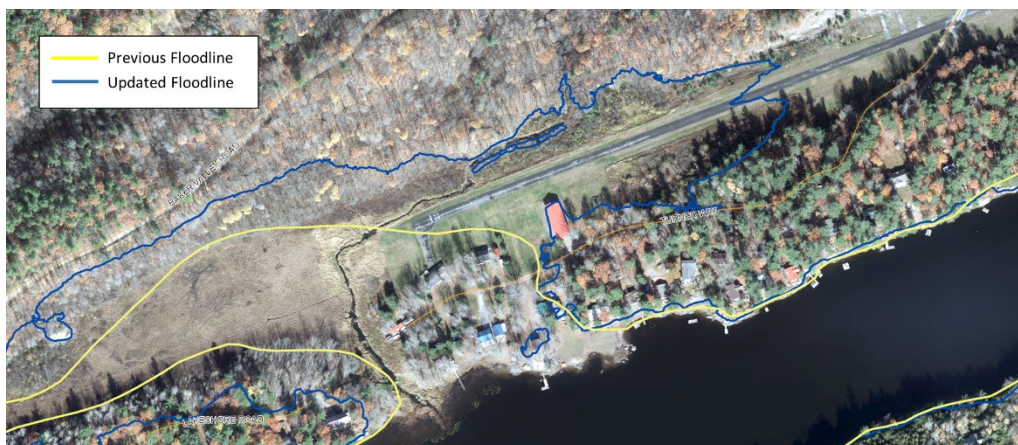
Along the north shoreline of Kennebec Lake, the study found some buildings and road segments within the floodplain. These are shown in Figure 4-2 (area near Bebris Rd) and in Figure 4-3 (area near Turner Way and the Baker Valley Airpark).

These areas were identified as part of the previous floodline; but the extent of the updated floodline is larger than the previous one in this part of the lake.

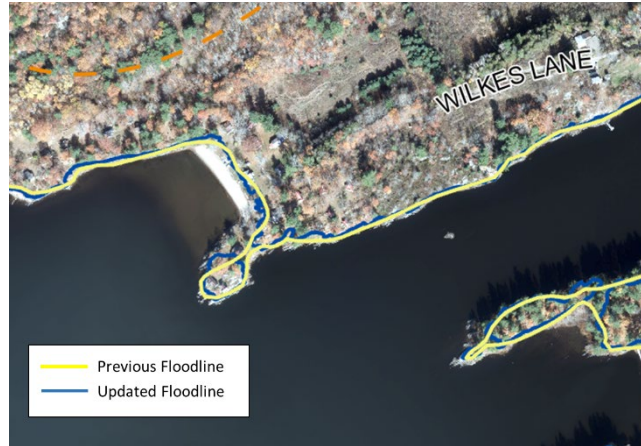
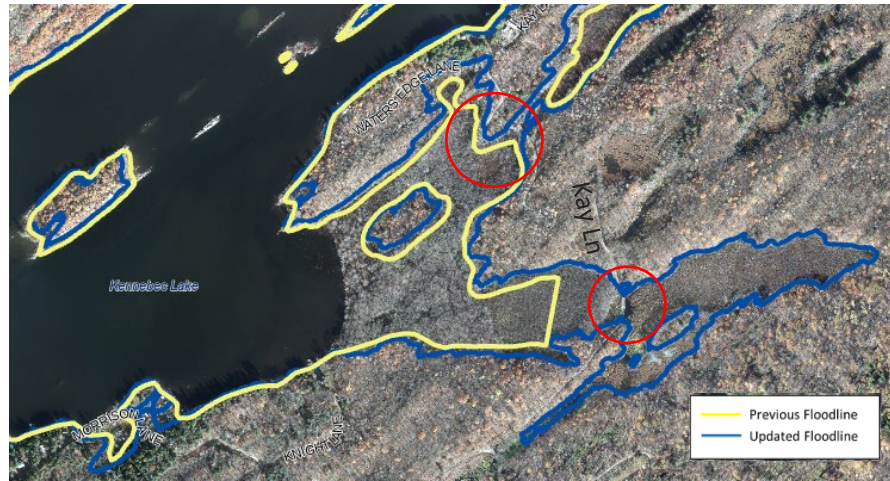
There were also some areas on the south shoreline of Kennebec Lake in which buildings were found close to or surrounded by the floodplain line. These were near Wilkes Lane (Figure 4-4) and near Morrison Lane (Figure 4-5). Also, in that area Kay Lane was found to be flooded by the updated floodplain at various locations (Figure 4-6) that had not been included in the previous floodplain.

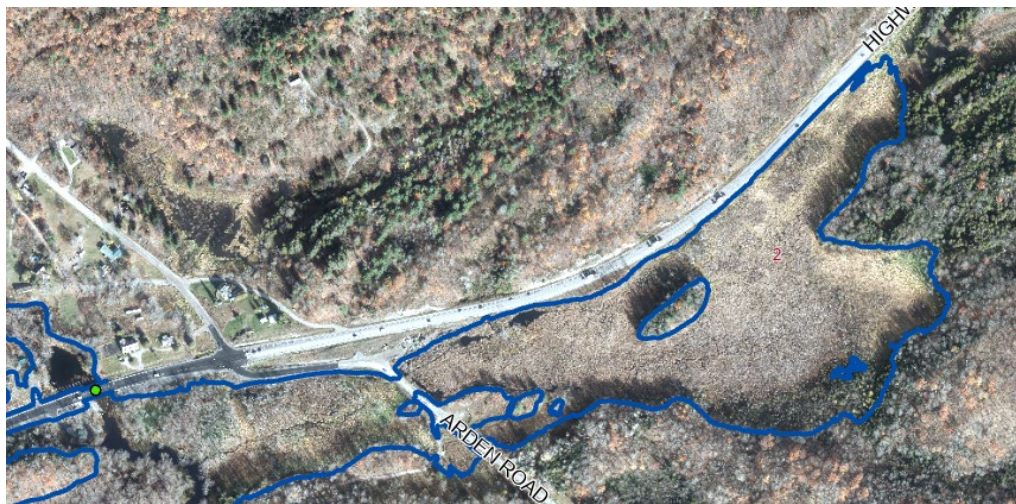
FIGURE 4-7: ARDEN RD NEAR HWY 7

Downstream of Kennebec Lake, the flooding obtained for the Regulatory Flood did not overtop the Hwy7 Bridge, but it overtopped a small low portion of Arden Road near the intersection with Hwy 7 (Figure 4-7). This area had not been included in the previous floodplain delineation.

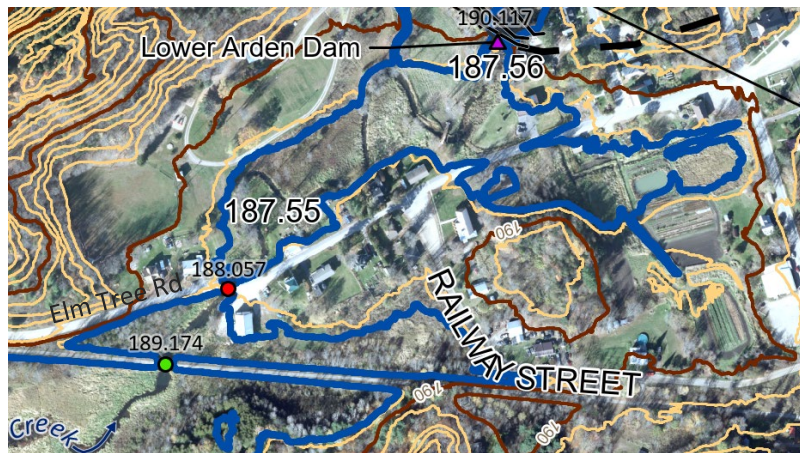
FIGURE 4-12: ARDEN CREEK DOWNSTREAM OF LOWER ARDEN DAM

Downstream of the Lower Arden Dam, the water levels, controlled by the levels on the Salmon River, further downstream, were found to overtop parts of Elm Tree Rd and some areas south of it, as shown in Figure 4-12.

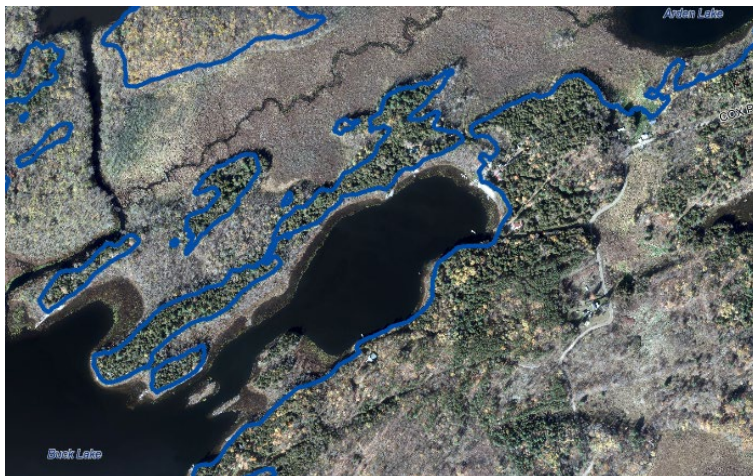
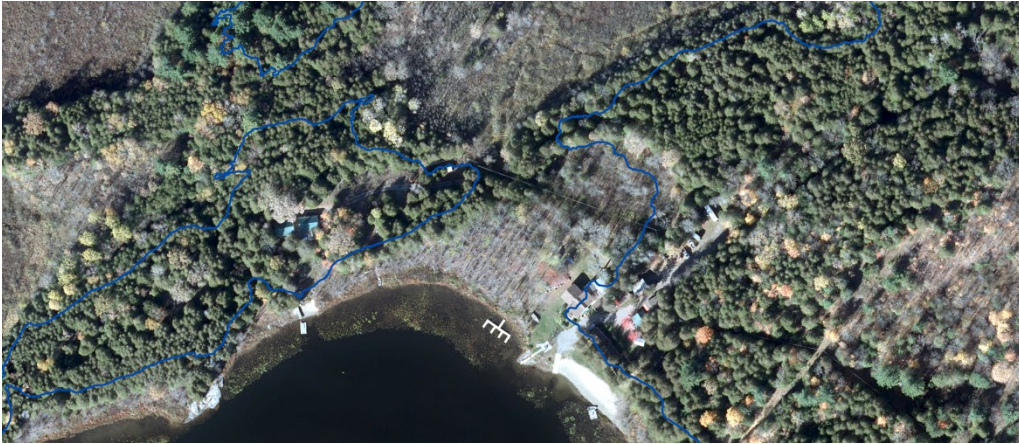
At the northeast end of Buck Lake, the flooding during the Regulatory Flood (as simulated) overtopped the banks of Arden Creek so that there would be flows bypassing from Arden Lake, directly into Buck Lake (Figure 4-14). There are buildings on that end of Arden Lake, that would be close or within the new floodplain (Figure 4-15).

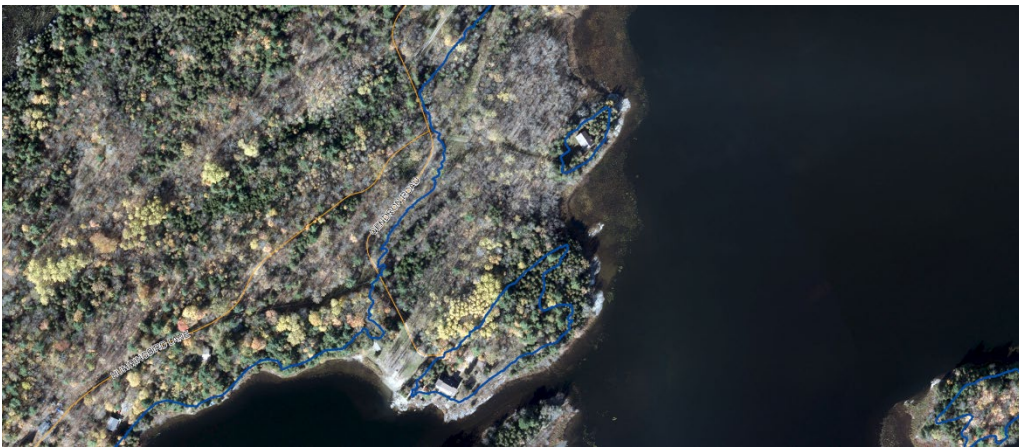
FIGURE 4-16: SOUTHWEST END OF BUCK LAKE

Near the southwest end of Buck Lake, the new floodline shows buildings that would be surrounded by the floodplain limits (Figure 4-16).

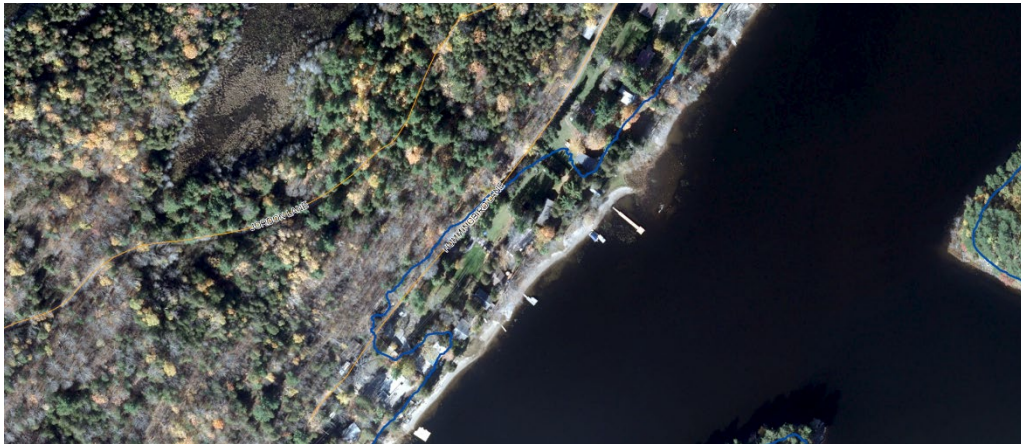
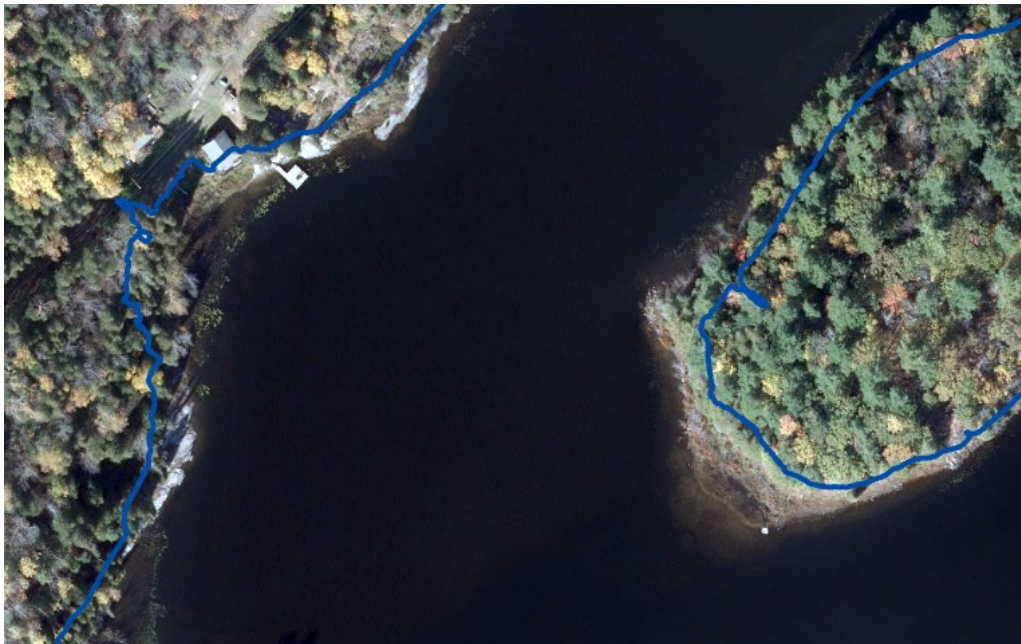
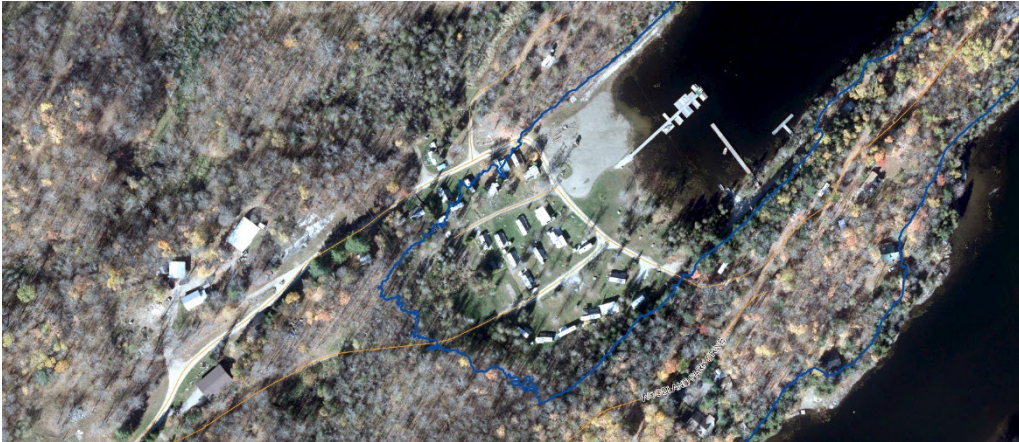
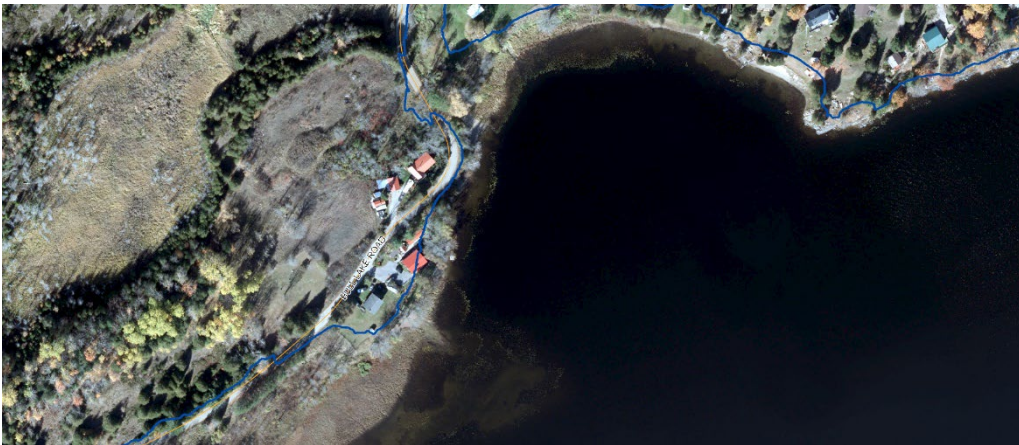
Along the north shoreline of Bull Lake, near Hummingbird Lane, the new floodline shows buildings located in low areas that would be within the floodplain (Figure 4-17 and Figure 4-18). Portions of Woodland Park, on Hummingbird Ln, would be within the floodplain (Figure 4-19). Near the southwest end of Bull Lake, at Bull Lake Rd, there is at least one building that would be within the floodplain (Figure 4-20).

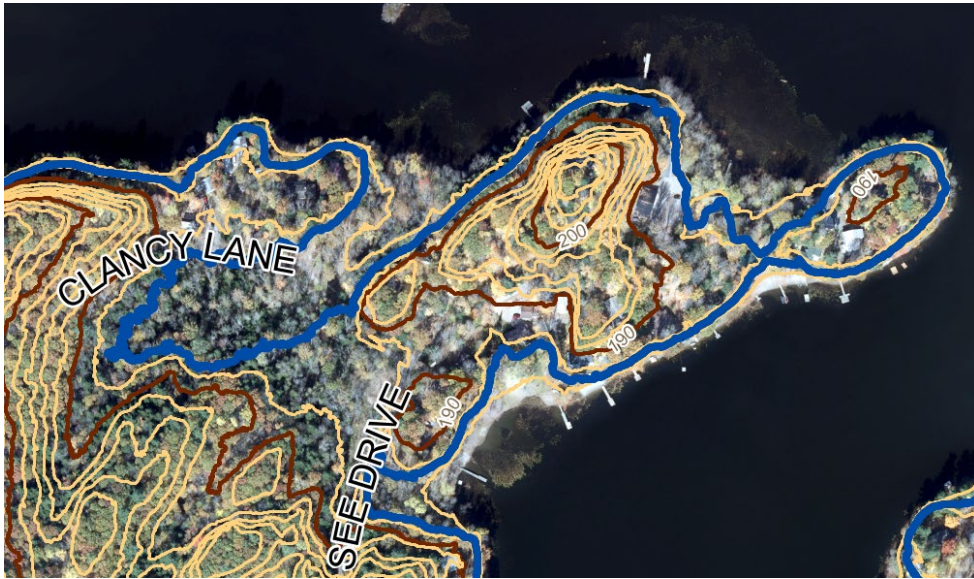
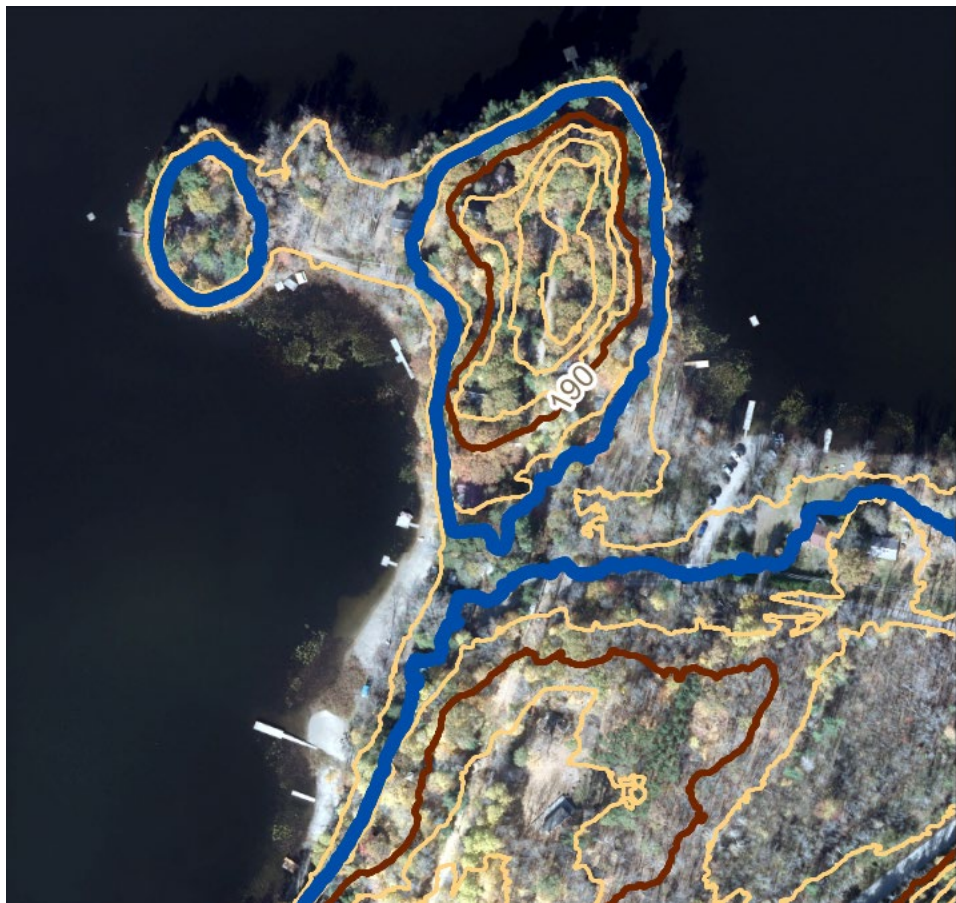
Near the northeast end of Horseshoe Lake, part of Clancy Lane was found to be within the floodplain (Figure 4-21). Also, at Horseshoe Lane, the boat launch and parking area would be within the floodplain. There is also a portion of Finch Ln that would be within the floodplain, limiting road access to the property located at the end of this road. (Figure 4-22).

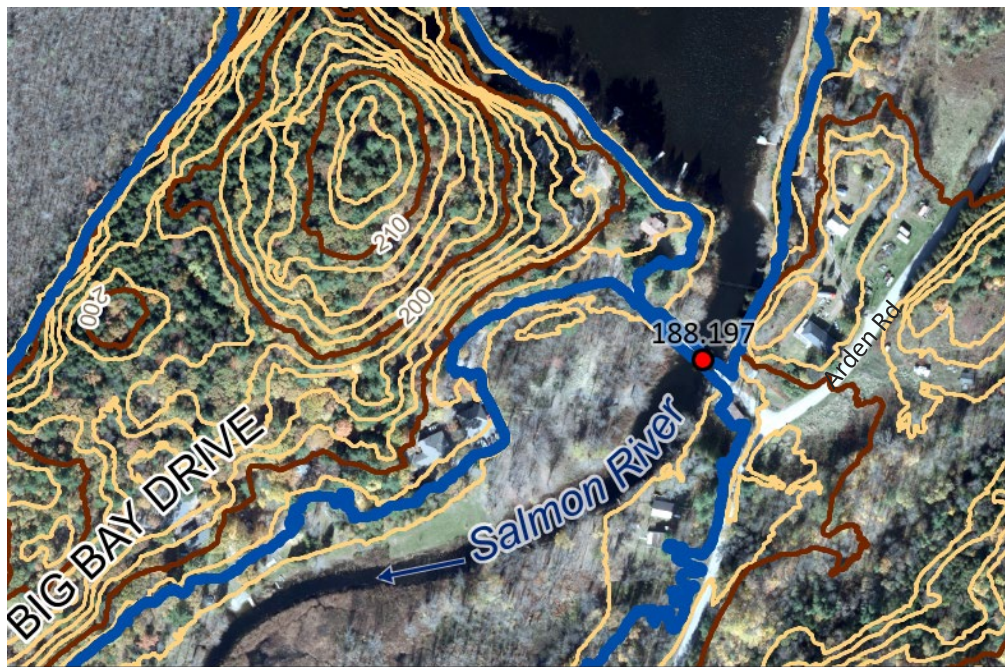
FIGURE 4-23: CRANBERRY LAKE RD AND ARDEN RD AT CROTCH LAKE

The area near the Cranberry Lake Rd crossing, between Horseshoe Lake and Crotch Lake, has been monitored for flooding by the Quinte Conservation. A low portion of the road just northwest of the bridge, experienced overtopping during the 2014 flood event. That part of the road would be overtopped as per the new floodline, and some buildings downstream of the bridge would be within the floodplain (Figure 4-23), with the water getting up to Arden Rd. Big Bay Drive was found to be not within the floodplain.

There were no bridges shown as overtopped for the Regulatory Flood. The bridge on Cranberry Lake Rd. would be close to overtopping.
